Manhole Inspection Summary

Manhole # S45C2_016MH

Location Address: **3605 Everett St**

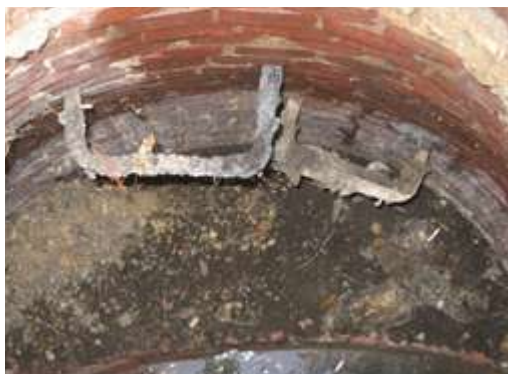
Steps Count: **2** Missing: **0** ☐ Corroded

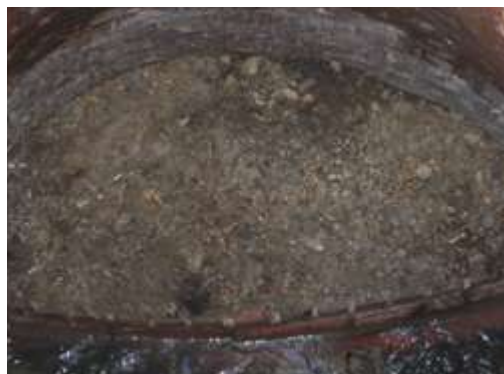
Defect 2

Condition: ☐ Sound ☐ Cracked ☐ Root Intrusion ☐ Deteriorated ☐ Leaks ☒ **Debris**

Debris

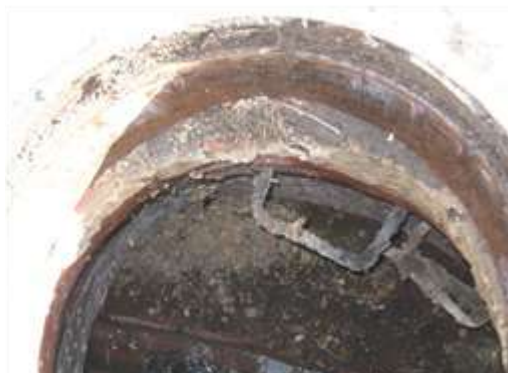
Defect 1

Frame Offset: **1.5** (in.) Condition: ☒ Sound ☐ Cracked ☐ Leaks

Frame offset

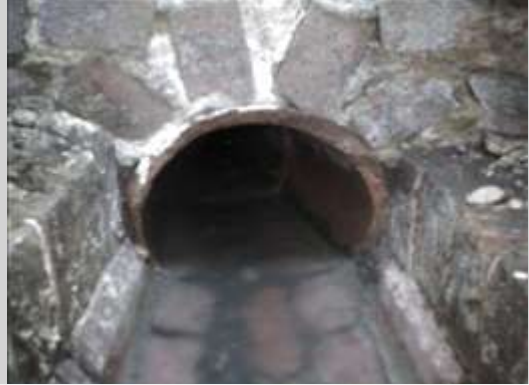
12 O'Clock Outflow

8 in. Circular Gravity Sewer
Pipe Out @ 12 O'Clock

Pipe Height: **8.4** (in.) Rod and Bar (Angled)
Pipe Material: **Clay** ☐ Pipe Lined
Invert Depth: **6.21** (ft.) Flow Characteristics: **Fast**
Deposits: ☒ None ☐ Mud ☐ Sludge ☐ Debris ☐ Grease
Silt Depth: (in.) Deposits Extent:
Infiltration: **None** Pipe Seal Cond: **Sound**

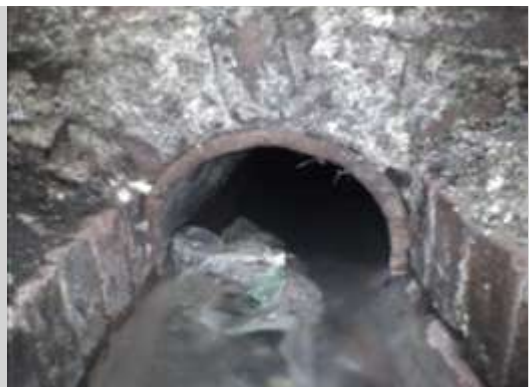
7 O'Clock Inflow

8 in. Circular Gravity Sewer
Pipe In @ 7 O'Clock

Pipe Height: **9.6** (in.) Rod and Bar (Angled)
Pipe Material: **Clay** ☐ Pipe Lined
Invert Depth: **6.42** (ft.) Flow Characteristics: **Fast**
Deposits: ☒ None ☐ Mud ☐ Sludge ☐ Debris ☐ Grease
Silt Depth: (in.) Deposits Extent:
Infiltration: **None** Pipe Seal Cond: **Sound**
